Appendix B
Air Sampling Results by Marcor
Case # K5823-013-7

Subject: MOSH Complaint 1718
Case No. K5823-013-97

RE: REPORT
Harford Fairmount Inst. #456,
Lead Dust Sampling & Analysis and
On Site XRF Analysis

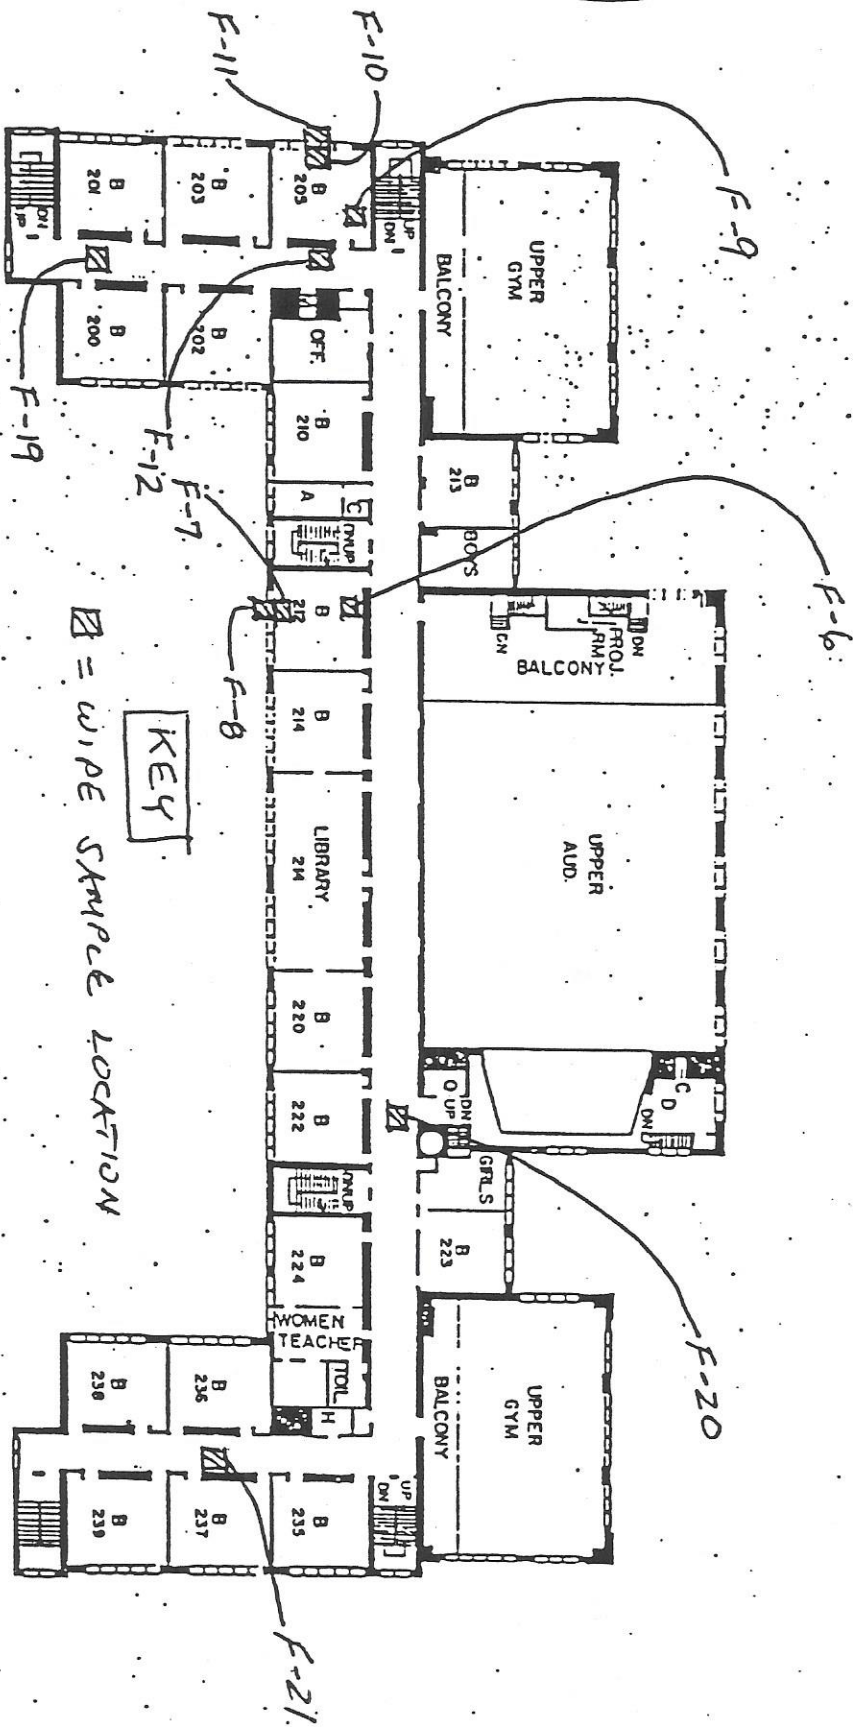
SECOND FLOOR PLAN ELEV. 158.5

LEAD DUST SAMPLE LOCATIONS

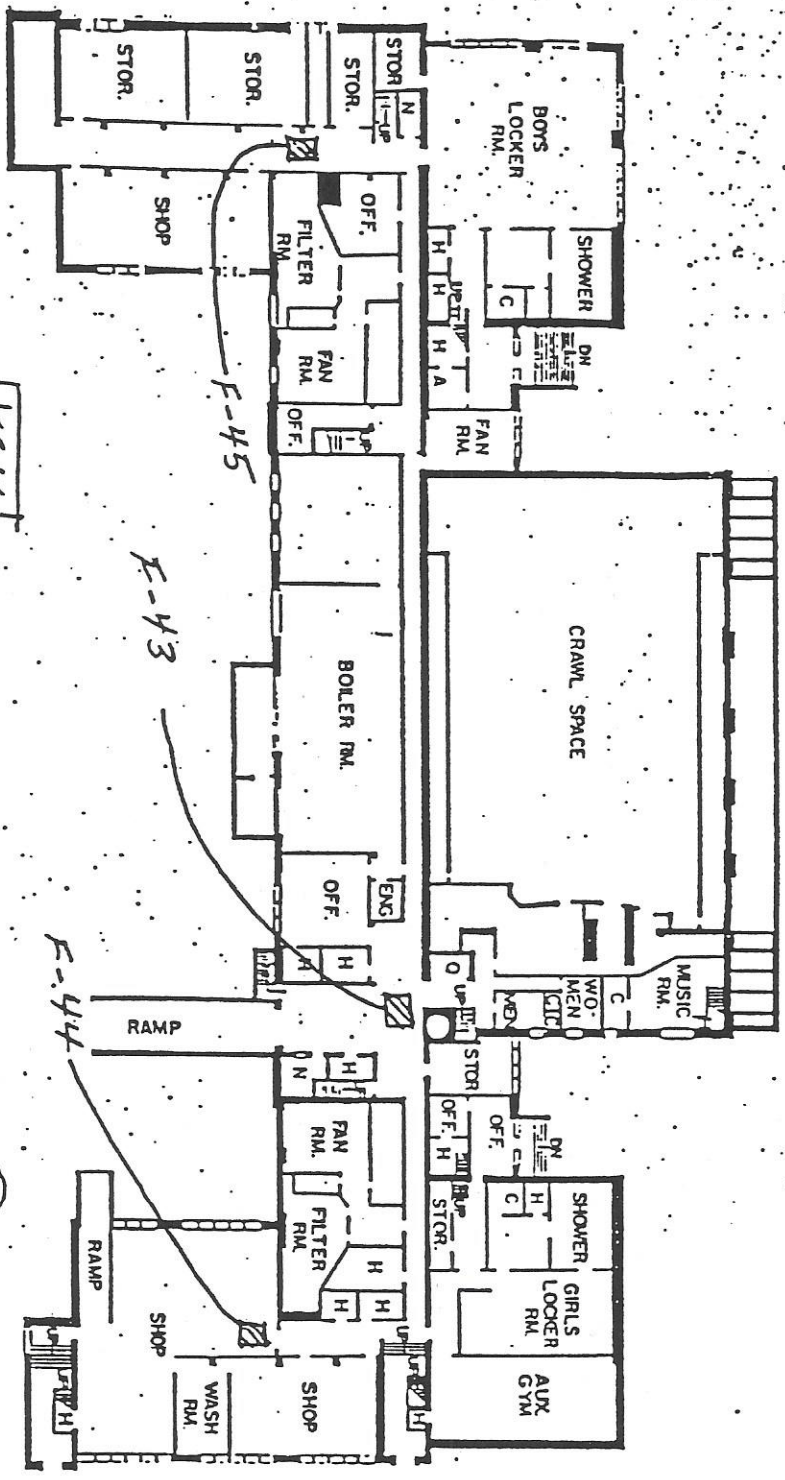
BASEMENT FLOOR PLAN ELEV. 13.5

LEAD DIST. SAMPLE LOCATIONS
